## Machinery Messages

### Case History

# Remote diagnosis of a pure *Half X* vibration problem in a power plant

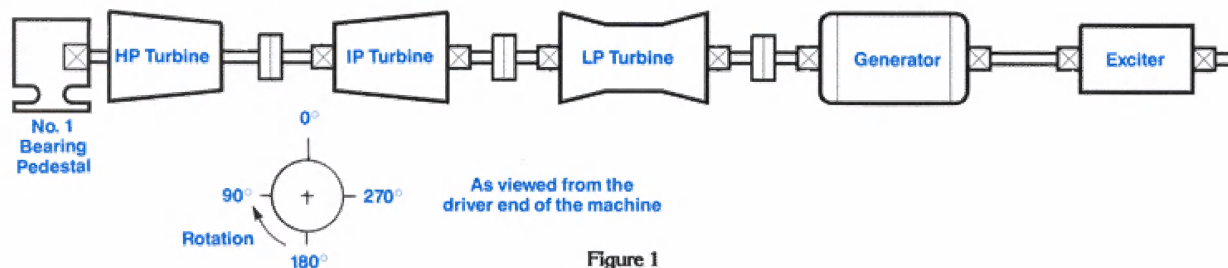
Figure 1  
Machine train diagram

This article discusses a problem which occurred on one of the 200 MW turbines. The machine train diagram (Figure 1) shows the general layout. All the shafts are solidly coupled.
